Failure Analysis of a Fuel Supply Tube of an Aircraft Engine

Abstract

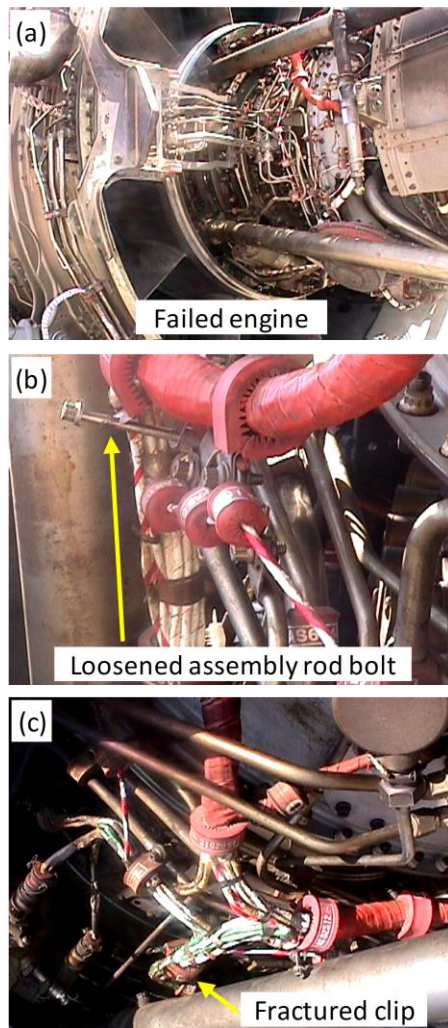
An onsite inspection of the damaged engine was conducted by personnel from the Central Directorate of Aircraft Accident Investigation (CDAAI). The inspection revealed key details about the assembly and fixation mechanisms used for electrical cables, hydraulic lines, and fuel tubes. Typically, these components are secured to the engine body using clips and bolts to protect them from the effects of engine vibrations. Observations of the failed engine are depicted in Fig. 1. A general view of the engine is shown in Fig. 1 (a) displaying the damage. The assembly mechanism of electric cables and fuel tubes is shown in Fig. 1 (b) and (c). The close-ups in Fig. 1 (b) and (c) indicate the loosened assembly rod bolt and the fractured clip, respectively. During the inspection, it was discovered that a fuel tube connected to the 2.5 master actuator was broken, leading to a significant fuel leak. Additionally, the clip responsible for securing the fuel tube to the engine body had broken, and the nut that was supposed to be fastened to the assembly rod bolt was missing, having detached during flight.

Fig. 1 Damage of the right engine: (a) general view of the engine, (b) close-up of the assembly rod bolt, and (c) close-up of the damaged cable assembly.

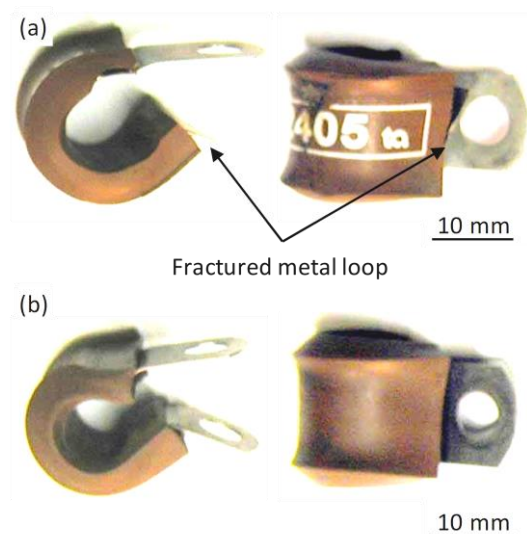
A detailed visual inspection of the fractured AS62405 clip revealed that only one of its terminals had failed, as illustrated in Fig. 2 (a). A general view of an undamaged clip is given in Fig 2 (b) for comparison. Close examination suggested that the fracture initiated from the inner surface of the hole located on the

terminal of the broken clip. Despite this fracture, there was no noticeable reduction in the clip's thickness at the fracture site indicating that the structural integrity of the remaining areas of the clip was largely preserved prior to failure. A dye penetrant test was conducted to check for surface cracks, in both the fracture zone and surrounding areas, but no surface cracks were detected.

Fig. 2 Photographs of (a) a damaged clip and (b) an undamaged clip.

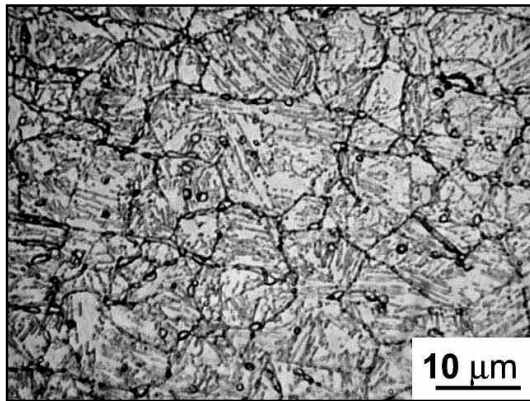
An optical micrograph depicting the cross-section of the fractured clip is presented in Fig. 3. The microstructural analysis reveals that the material exhibits characteristics consistent with a solution-treated and subsequently reheated condition. The predominant structure comprises a tempered martensite matrix, dispersed with ferrite stringers and carbide precipitates located at the grain boundaries and within the grains themselves. This specific microstructure has been verified by hardness measurements, which yielded an average hardness of 373 HV, consistent with the expected characteristics of tempered martensitic stainless steel.

Fig. 3 Microstructure of the broken clip.

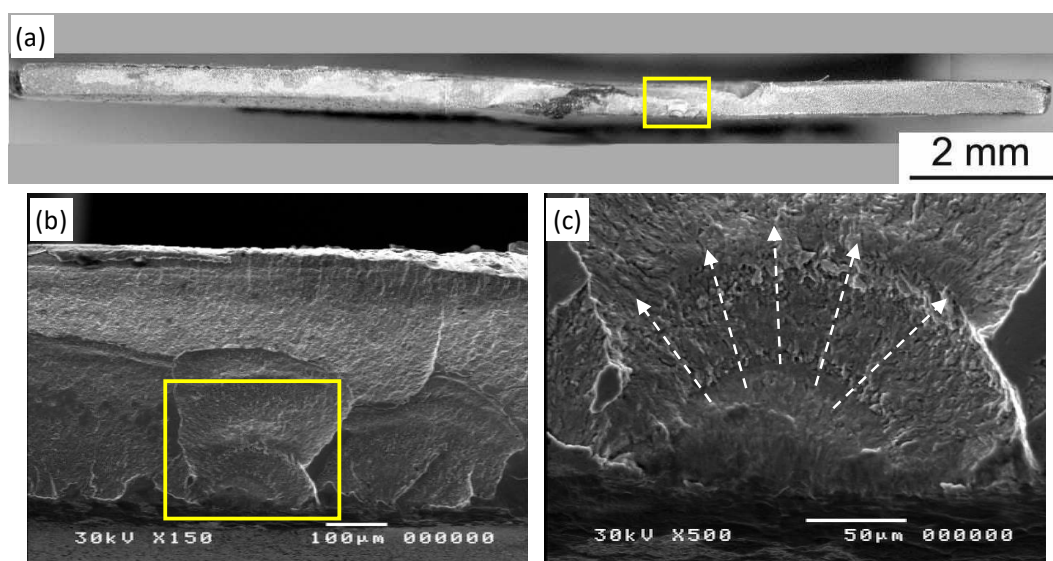
A low-magnification stereoscopic image of the fracture surface of the clip is illustrated in Fig. 4 (a). Notably, minimal reduction in thickness was observed across the fractured area. The image highlights a specific zone where the fracture likely initiated—located at the inner surface of the hole in the clip's terminal. This area was marked by a yellow rectangle as the most probable point of fracture initiation.

Radial marks, which are characteristic of fatigue failure, were observed, radiating from the identified initiation point as seen in Fig. 4 (b). These radial markings clearly indicated the direction in which the fracture propagated, as shown by the arrows in Figure 4 (c). Upon examining the fracture surface at higher magnifications, additional evidence of fretting fatigue was detected around the initiation zone, as shown in Fig. 5 (a) and (b). Slip regions characteristic of fretting fatigue were observed and marked by arrows in Fig. 5 (b). Fretting fatigue typically occurs due to small oscillatory movements that create wear and crack initiation under cyclic loading [13].

Fig. 4 Fracture surface of the broken clip: (a) Low magnification stereoscopic photograph, (b) a magnified SEM image of the boxed area in (a), and (c) a magnified SEM image of the boxed area in (b).

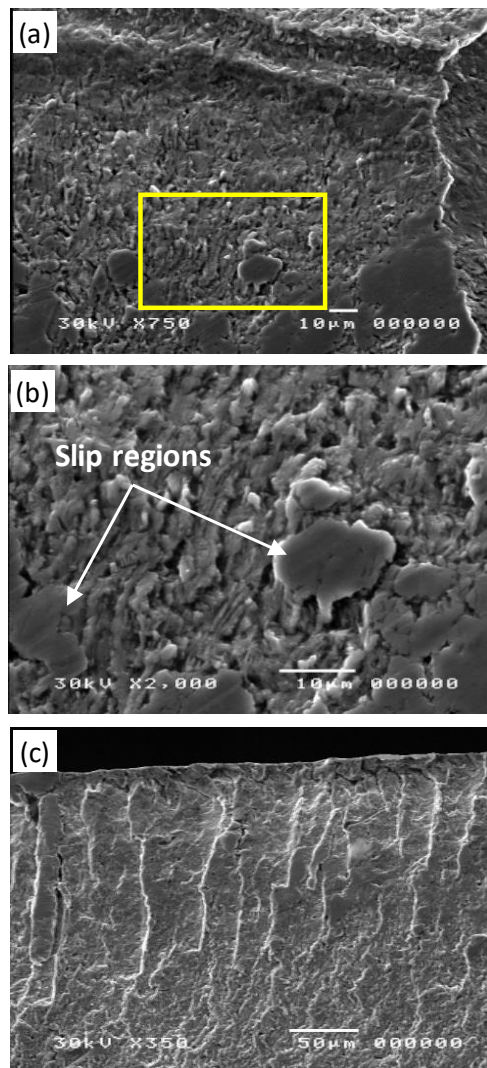
As the fracture progressed, a transition to a brittle fracture mode was observed near the termination zone of the crack, as displayed in Fig. 5 (c), indicating a change in the failure mechanism as the fracture approached completion. This combination of fatigue and brittle fracture suggests that the clip underwent sustained cyclic loading before ultimately failing in a more abrupt manner.

Fig. 5 (a) A SEM image of the clip's fracture surface showing indications for fretting fatigue, (b) a magnified SEM image of the boxed area in (a), and (c) a SEM image at the termination zone of the fracture.

The analysis indicates that the fracture of the clip was predominantly caused by fretting fatigue. This condition arose from the sliding contact between the surfaces of the fuel tube assembly rod bolt and the clip hole, which experienced minute alternating relative motion due to vibration. Under such fretting conditions, fatigue cracks can initiate at stress levels significantly lower than those typically associated with non-fretted components.

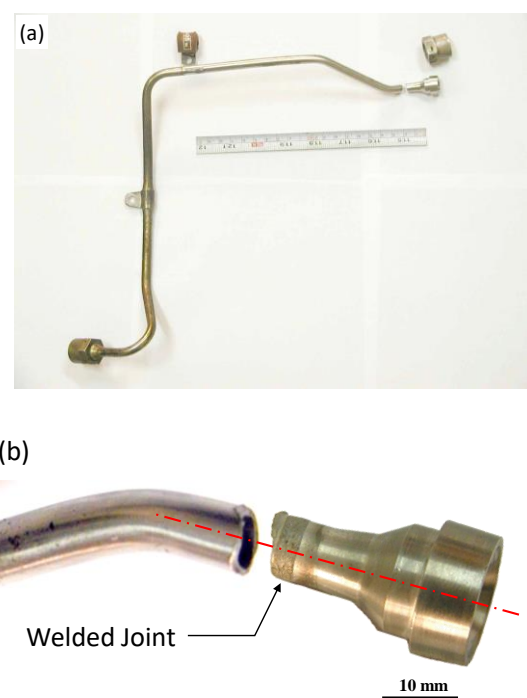
A general visual examination of the fractured fuel supply tube assembly is illustrated in Fig. 6 (a), while a detailed view of the fracture zone is presented in Fig. 6 (b). Initial visual inspections indicated that the fuel supply tube had failed, resulting in a separation into two distinct sections, as depicted in Fig. 6 (a). The tube is secured at both ends by inner screw reducers, which are connected through butt-welded joints. Notably, the fracture was located on the tube side of the butt welded joint rather than on the reducer side.

Fig. 6 (a) A general view of the fractured fuel supply tube, and (b) a close-up of the fracture zone.

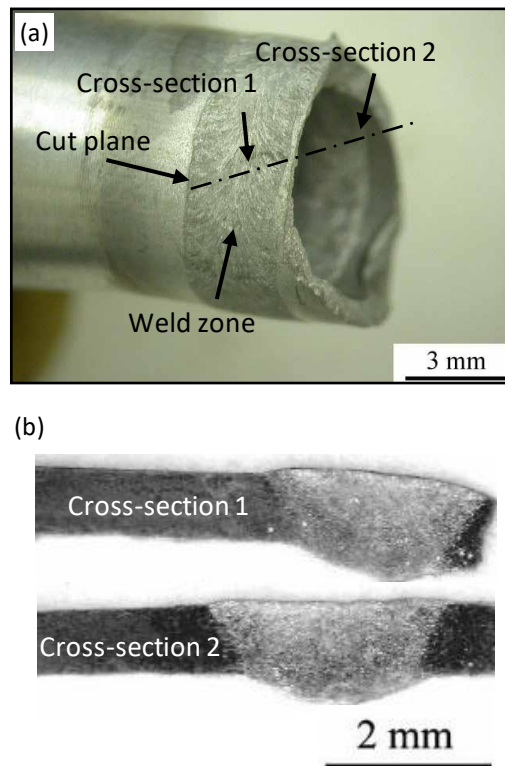
The fracture surface of the fuel tube, along with longitudinal cross-sections oriented perpendicular to the fracture plane, are depicted in Fig. 7 (a) and (b), respectively. Notably, certain zones of the fracture surface exhibited signs of obliteration due to post-separation rubbing, which may have obscured some features critical for failure analysis.

Importantly, no significant reduction in wall thickness was detected throughout the length of the tube, indicating that the material's structural integrity remained largely intact until the point of failure. The fracture originated within the heat-affected zone (HAZ) of the circumferential butt welded joint, a critical area where thermal influences from welding can alter material properties.

Fig. 7 (a) Fracture zone of the fuel supply tube, and (b) fusion zone macrostructure of the tube circumferential butt welded joint.

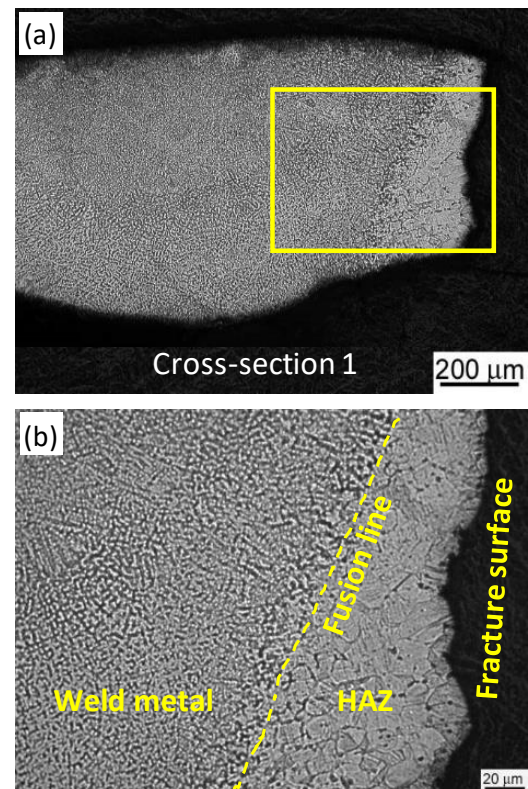
Higher magnification optical micrographs of both the weld metal and the HAZ of cross-section 1 are presented in Fig. 8. These images reveal that the initiation of fracture occurred in the HAZ, very close to the fusion line of the butt weld, and extended into the base metal, indicating a potential weakness in this region. The microstructural analysis confirms that both the weld metal and HAZ display typical austenitic structures characteristic of type 347 stainless steel welded joints. In contrast, the microstructure of the base metal exhibits a non-uniform distribution of austenite grains, dispersed with carbide precipitates along the grain boundaries, as illustrated in Fig. 9. Importantly, no internal defects were identified in any of the examined regions, including the base metal, HAZ, or weld metal. The hardness measurements obtained from

Fig. 8 (a) Microstructure of cross-section 1 in Fig. 7 (b), and (b) a magnified view of the boxed area in (a).

these areas were consistent with expected values: 235 HV for the base metal, 260 HV for the HAZ, and 230 HV for the weld metal, indicating that material properties were within acceptable limits for the base and weld metals, while a relative hardening was observed in the HAZ.

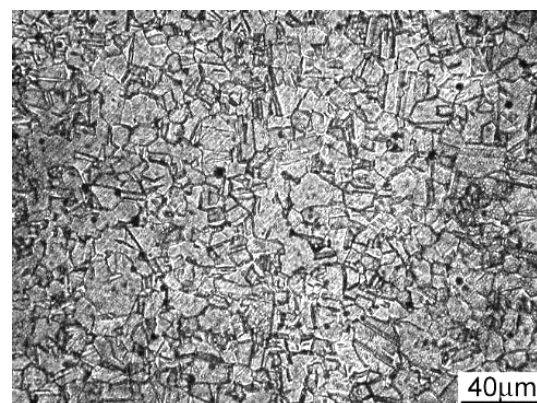
Fig. 9 Base metal microstructure of the fractured fuel tube.

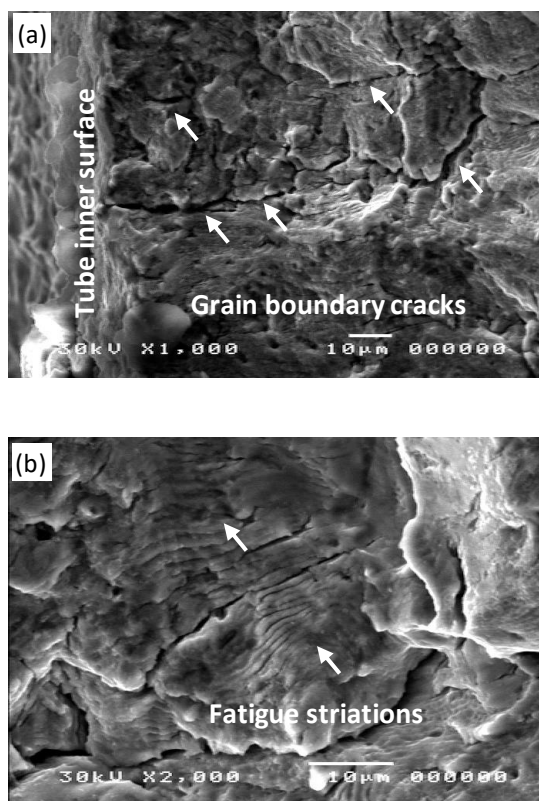
Applying deeper examination using SEM, it was observed that grain boundary cracking initiated at the inner surface of the tube, as seen in Fig. 10 (a). The presence of distinct fatigue striations across various zones of this inner surface suggests that low-cycle fatigue played a significant role in the fracture process, as evidenced by Fig. 10 (b). This observation points to multiple initiation sites contributing to the overall failure mechanism. Additionally, a brittle fracture mode was identified around the termination zone on the outer surface of the tube, as shown in Fig. 11, highlighting a complex synergy between fatigue and brittle failure modes in this incident.

Fig. 10 SEM images of the fuel tube fracture surface showing: (a) grain boundary cracks, and (b) fatigue striations.

The failure of the fuel supply tube is primarily linked to fatigue mechanisms. The loosening of the fuel tube assembly rod bolt, along with the resultant failure of its clip hole, imposed abnormal alternating loads on the fuel tube during engine operation. These atypical vibrational forces likely contributed to fatigue failure. Notably, fatigue cracking was initiated at the inner surface of the tube, particularly in regions characterized by high hardness within the coarse grain HAZ of the butt welded joint.

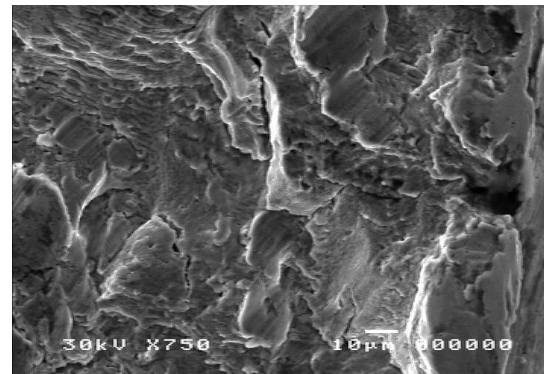
Fig. 11 A SEM image of the fuel tube fracture surface at the crack termination zone.
