Improving the performance of domestic pin punches using failure analysis investigation techniques

Dina Mahmoud*, Waleed Khalifa

Department of Mining, Petroleum and Metallurgical Engineering, Faculty of Engineering, Cairo University, Cairo, Egypt

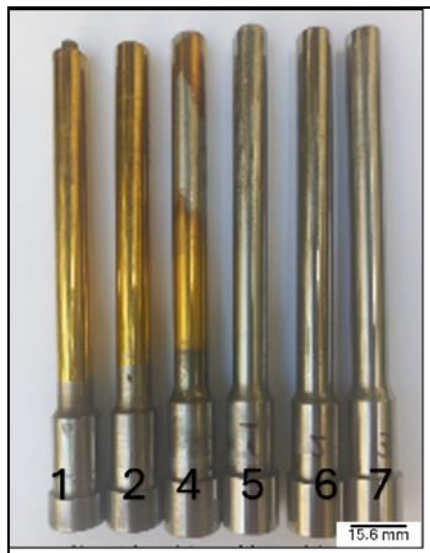
Sample number 1: This sample represents pin punch of the original material, which is the M50 tool steel. I was coated with TiN layer as shown in Figure 3. The pin punch was in good condition. The coating layer was partially removed from the tip during service. The performance of the punch was not affected by this.

Fig. 3 (1) original punch, (2) original failed punch, (3) equivalent K110 punch, and (4-6) three local manufactured failed punches.

Sample number 2: This sample represents the original M50 tool steel punch after failure. This punch was coated with TiN layer (Figure 3). The coating was also partially stripped from the surface during service. This partial removal facilitated crack initiation leading to fatigue fracture [29], [30].

Sample number 4: This sample represents failed punch with equivalent material D2 tool steel. The sample showed lower performance compared to M50 steel because of its lower fracture toughness compared to M50 steel [15], [31], [32]. This punch was also coated with TiN layer as shown in Figure 3. The coating layer was partially damaged during operation. This might explain the low performance of this punch, which is 50% lower than the original one. The fracture surface is shown in Figure 4. The macrograph shows clear multiple origin fatigue fracture surface. Ratchet marks are seen between the origins as well.

Sample number 5 represents a local punch manufactured from the Slippner tool steel. This punch was not coated with the TiN layer, as shown in Figure 3. The fracture mode was

Sample number 6: This sample represents failed uncoated local manufactured failed punch of Slippner tool steel (Figure 3). From the fracture surface of Figure 4, it is likely failure due to an accident. It is not similar to the previous surfaces, even though characteristic fatigue features are seen such as multiple origins and other features.

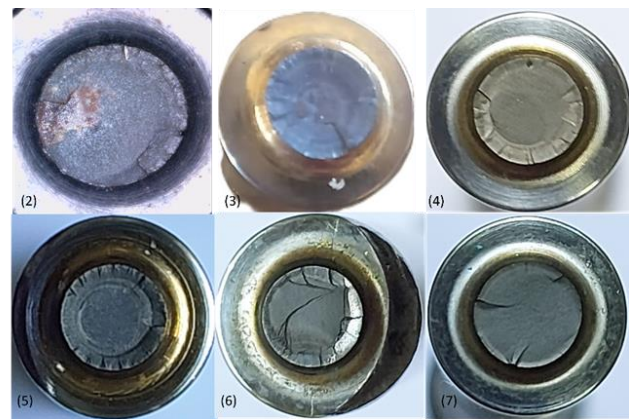
Sample number 3: This sample represents failed original M50 tool steel pin punch after failure. This punch was coated with TiN layer. The fracture surface is a fatigue similar to sample number 2, as can be seen in Figure 4.

Sample number 7: This sample represents a locally manufactured punch from the M3 class 2 tool steel, which has high strength but moderate toughness [15]. This punch is not coated with a TiN layer, as shown in Figure 3. The fatigue fracture surface is also seen in Figure 4. This pin punch also failed due to fatigue. But this material might have different hardness than the rest of the punches. Origins and ratchet marks can be identified.

Fig. 4 Photographs of fracture surface: samples no.2,3,4,5,6,7 respectively.

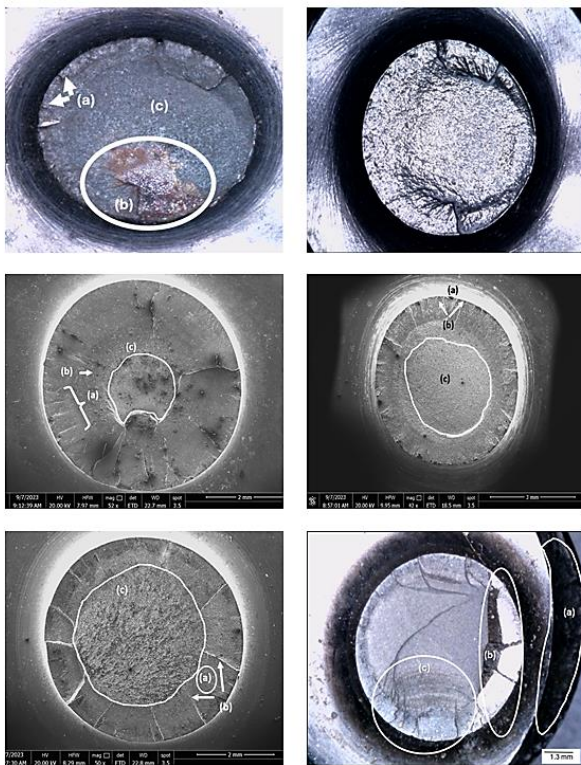
Sample no. 2: At higher magnification as shown in Figure 5-2, multiple origins and ratchet marks are observed. The area was cleaned by washing in alcohol ultrasonic path, then polished slightly with alumina and then dried with dryer. The fracture surface of this sample is not of good quality as shown in Figure 5-2-a.

Sample no. 3: The SEM macrograph is shown in Figure 5-3. Typical ratchet marks, multiple origins and beach marks are seen. These confirm the fatigue fracture. The final fracture zone is very small, *i.e.*, 2.54 mm² compared to total fracture area, *i.e.*, 15.4 mm², constituting only 11.6% of the surface. This indicates the proper design and/or the suitable material properties. This punch showed the best performance.

Fig. 5 Stereoscopic examination for samples no. 2 before cleaning, sample no. 2 after cleaning, SEM examination at 50X for samples no. 3,4, 5 and 6.

Sample no. 4: The SEM macrograph is shown in Figure 5-4. Typical ratchet marks, multiple origins, and beach marks are seen. These confirm the fatigue fracture. The final fracture zone is large, *i.e.*, 7 mm² compared to the total fracture area, *i.e.*, 15.4 mm², constituting only 45% of the surface. This indicates the proper design and/or the suitable material properties. This punch showed accepted performance as an equivalent material.

Sample no. 5: The SEM macrograph is shown in Figure 5-5. Typical ratchet marks, multiple origins, and beach marks are seen. These confirm the fatigue fracture. The final fracture zone is very large, *i.e.*, 11.03mm² compared to the total fracture area, *i.e.*, 15.4 mm², constituting only 71.6% of the surface. This indicates the proper design and/or the suitable material properties. This punch showed accepted performance as an equivalent material. The fracture segments of the first stage of fatigue clearly appear. The sample contains 18 crack origins and 19 ratchet marks. The primary macroscopic examination shows that the final fracture zone of sample no.5 is very large compared to the total fracture area and seems to be a ductile fracture. This

means that slippner tool steel either was not treated well or was not the suitable material for this pin punch as the punch could not withstand the applied force even over a large area. **Sample no. 6:** The macroscopic examination clarified the accident effects, especially in zone (a), as shown in Figure 5-6. It appears that a malfunction in the punching process led to a fracture. The fracture surface shows ratchet marks, multiple origins, and beach marks, which appear in zone (c).

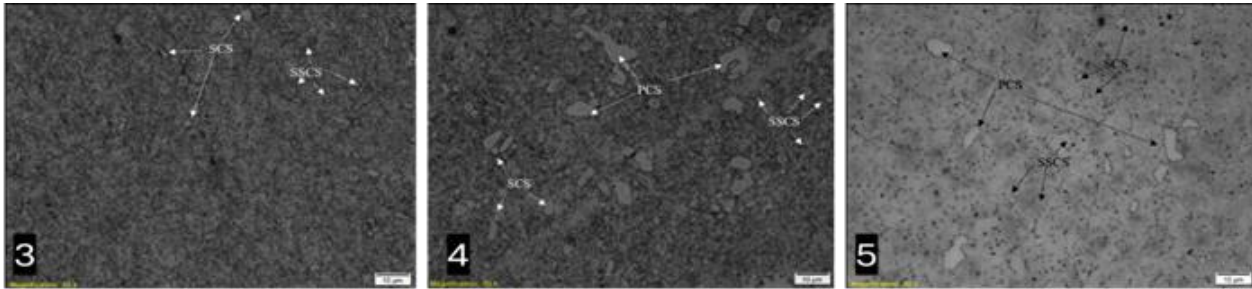
Sample no. 3: The microstructure of M50 steel at 50X as shown in Figure 6. Shows the presence of carbides distributed inside the tempered martensitic matrix in the form of secondary carbides, either large secondary carbides or small secondary carbides [34].

Sample no. 4: The microstructure of D2 in Figure 6 shows the presence of undissolved chromium carbides distributed inside the matrix. These carbides are divided into a small number of elongated dendritic primary carbides (PCS) and a large number of secondary carbides, either in large secondary carbides or small secondary carbides in a tempered martensitic matrix.

Sample no. 5: The microstructure of Slippner shows the presence of undissolved chromium carbides distributed inside the matrix. But with a small number of primary carbides, a medium number of secondary carbides, and very high amounts of small secondary carbides, as shown in Figure 6. After microstructure examination, it was found that there were differences between the samples that appeared in the form of carbide sizes and distributions.

Fig. 6. Microscopic examination for samples no. 3,4 and 5, respectively, at 50X.

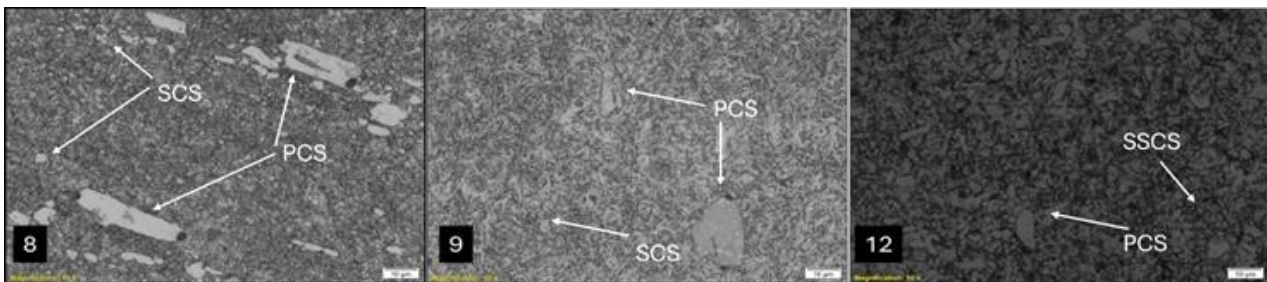
Fig. 7. Microscopic examination for samples no. 8,9 and 12, respectively, at 50X.

Sample 8 (22,000 Punches): shows large amounts of primary carbides (PCS) which make stress concentration inside the matrix and accelerate crack initiation reducing tool life and leading to fatigue fracture. These carbides are sufficient for decreasing the production rate as shown in Figure 7-8.

Sample 9 (140,000 Punches): microstructure in Figure 7-9 which shows small amounts of primary carbides (PCS) and large amounts of secondary carbides (SCS) especially small secondary carbides (SSCS). This number of secondary carbides (SCS) enhances both toughness and fatigue resistance, which is likely contributing to the improved production rate in this set.

Microscopic examination pin punch with tailored heat treatment. As shown in Figure 7, sample number 12 exhibits a very uniform structure, small primary carbides (PCS) distributed along the martensitic matrix, and a large amount of small secondary carbides (SSCS). This microstructure indicates an optimized carbide structure

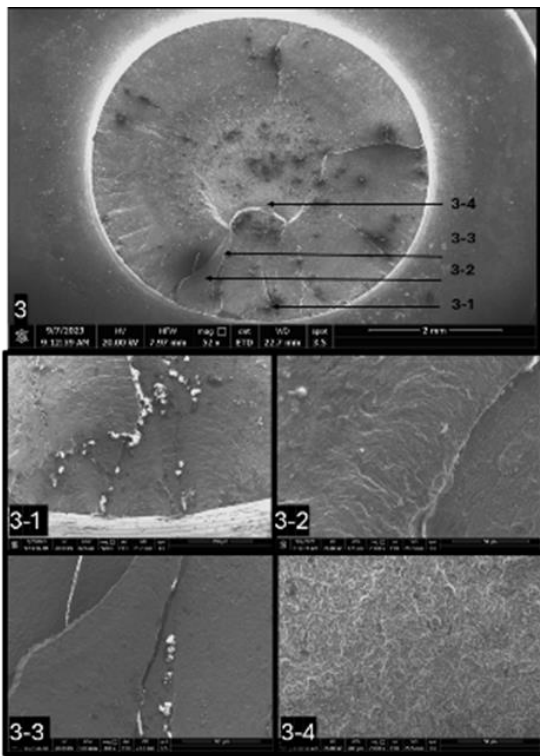
Figure 8-3-3 shows crack layer on the surface of fracture surface.

Figure 8-3-4 represents part of the final fracture zone at a magnification of 2000X, showing quasi-cleavage fracture and internal crack.

Fig. 8. SEM examination of sample no.3 different zones with different magnifications 3) at 60 x magnification showing the zones that magnified, 3-1) at magnification 500X showing fatigue striations, 3-2) at magnification 2400X showing fatigue striations, 3-3.

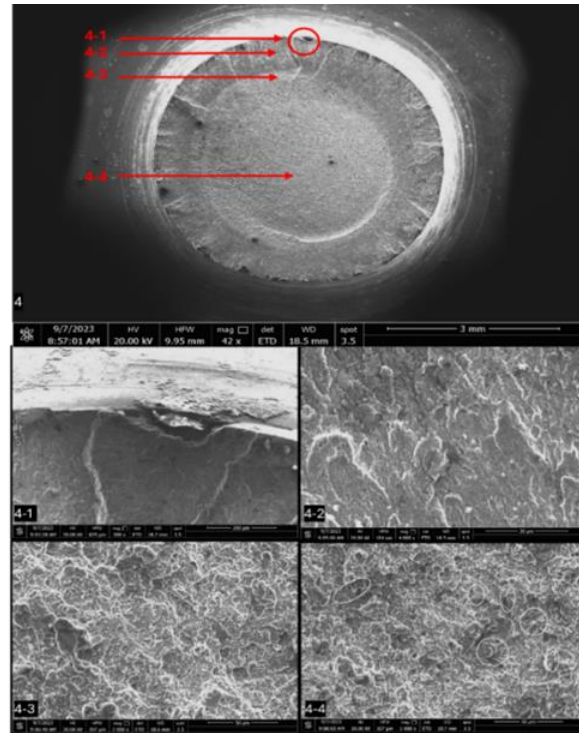
Figure 9-4-1 shows the crack origin and ratchet marks.

Figure 9-4-2, Figure 9-4-3, and Figure 9-4-4 are close-up views. Quasi-cleavage morphology of fatigue fracture.

Figure 9-4-4 shows the final fracture zone at 2000X magnification, showing a large number of intergranular fractures with deep secondary cracks between the grains.

Fig. 9. SEM examination of sample no.4 different zones with different magnifications 4) illustrating the location of different fracture mechanisms is clearly demonstrated, 4-1), 4-2), 4-3), and 4-4).

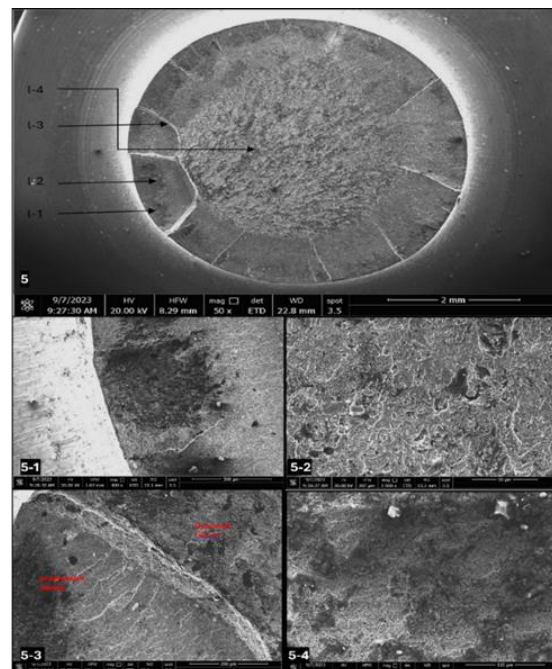
Figure 10-5-2 shows quasi-cleavage fracture containing voids AT 2000X magnification.

Figure 10-5-3 this location represents transition zone from progressive failure to overload failure with separation surface. Progressive failure is marked by crack propagation under cyclic loading, followed by overload exceeding the material's capacity. Figure 10-5-4 shows final fracture zone at 1200X magnification depicting mostly ductile feature.

Fig. 10. SEM examination of sample no.5 different zones with different magnifications 5) illustrating the location of different fracture mechanisms is clearly demonstrated, 5-1), 5-2), 5-3), and 5-4).

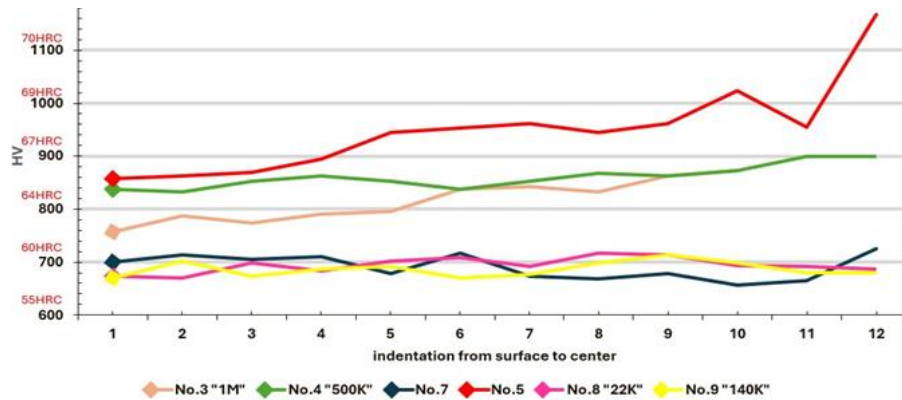
Comparing the hardness measurements data shown in Table 4, it was found that the samples number 3 and 4 which characterized with highest production rate and long lifetime have nearly the same hardness gradient and ranges. Unlike sample number 5 which has the highest hardness and sample no. 7. Which have the lowest hardness and more ductile, this appears in hardness chart in Figure 11.

Fig. 11 Microhardness chart of sample no. 3,4,5, 7, 8 and 9.
